# Mixing Metallurgy: Reliability of SAC Balled Area Array Packages Assembled Using SnPb Solder

Heather McCormick

May 16, 2007

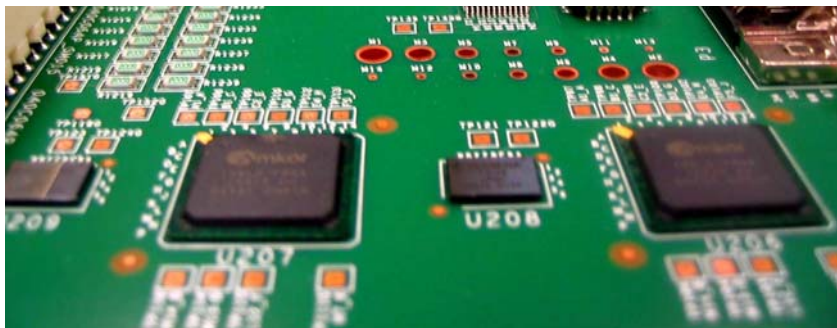
- Three Components Selected
  - PBGA256
  - PBGA196
  - CSP46

Component	Pitch	Alloy	Ball Diameter
PBGA256	1.27 mm	SAC 305	0.75 mm
PBGA256	1.27 mm	SAC 405	0.75 mm
PBGA196	1.00 mm	SAC 305	0.60 mm
PBGA196	1.00 mm	SAC 405	0.50 mm
CSP46	0.75 mm	SAC 305	0.30 mm
CSP46	0.75 mm	SAC 405	0.35 mm

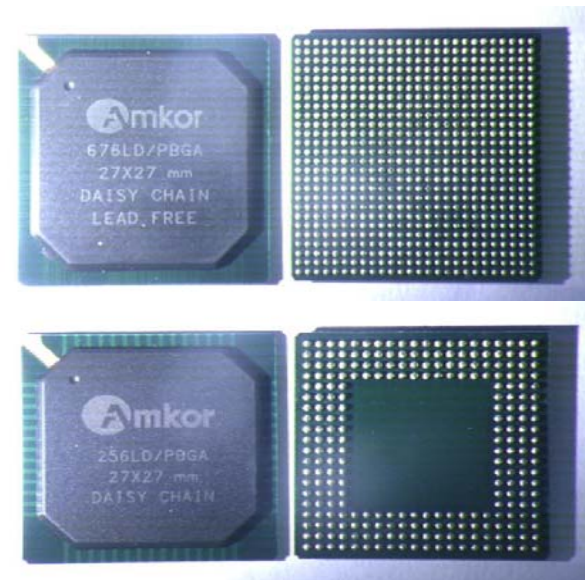
- Four Components Selected
  - PBGA676
  - PBGA256
  - PBGA196
  - CSP64

Component	Pitch	Alloy	Ball Diameter
PBGA676	1.00 mm	SAC 305	0.63 mm
PBGA676	1.00 mm	SAC 405	0.63 mm
PBGA256	1.27 mm	SAC 305	0.75 mm
PBGA256	1.27 mm	SAC 405	0.75 mm
PBGA196	1.00 mm	SAC 305	0.50 mm
PBGA196	1.00 mm	SAC 405	0.50 mm
CSP64	0.75 mm	SAC 305	0.46 mm
CSP64	0.75 mm	SAC 405	0.46 mm

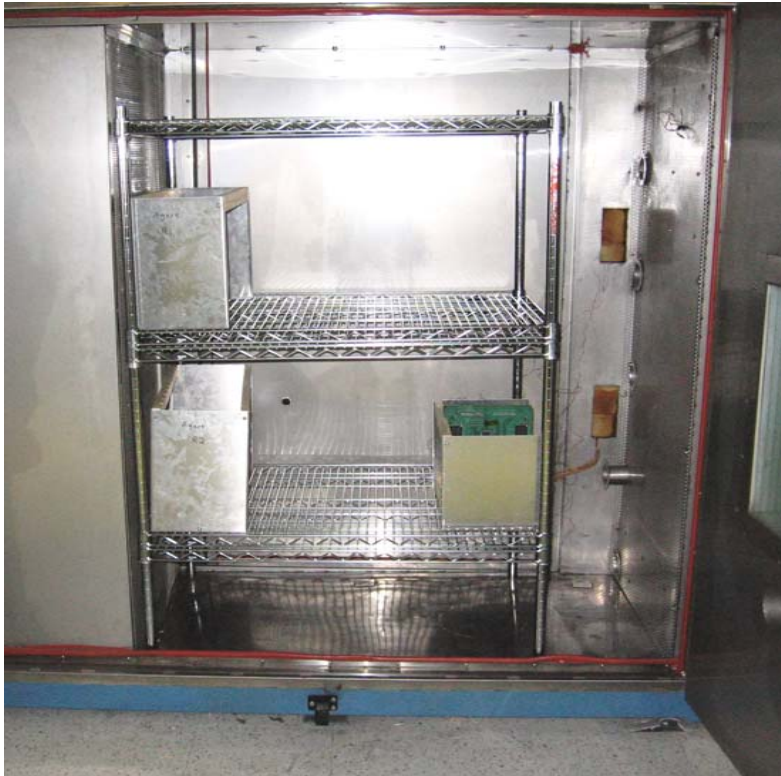
- Conducted in Accordance with IPC-9701
- 6000 Cycles, 0°C to 100°C
- 100% In-situ Monitoring using Dataloggers
- Failure Criteria: Five consecutive readings showing minimum 20% Resistance Increase over max. resistance recorded during the hot dwell on the first cycle
